SWM0153270010(TRM), SWM01532700BODY
Wall Mounted Lavatory Faucet
Operation and Maintenance Manual

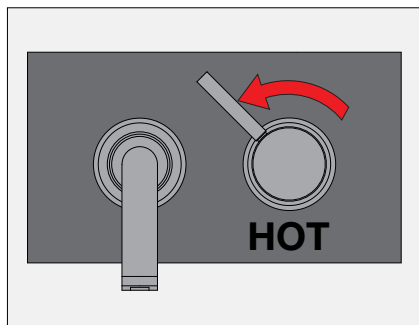
2) Turn counter-clockwise to put faucet handle in the **hot** position.

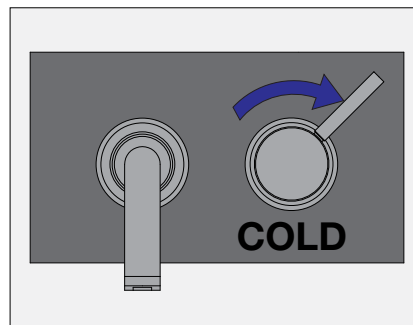
3) Turn clockwise to put faucet handle in the **cold** position.
